## **FSN 2020-02 – Bolts need to be replaced at the next product service**

Affects both the UNIVERSAL/SR/MAG/CH Standard bed rails and UNIVERSAL/SR/HI/MAG/CH Extended bed rail supplied onto the market after Nov 2017.

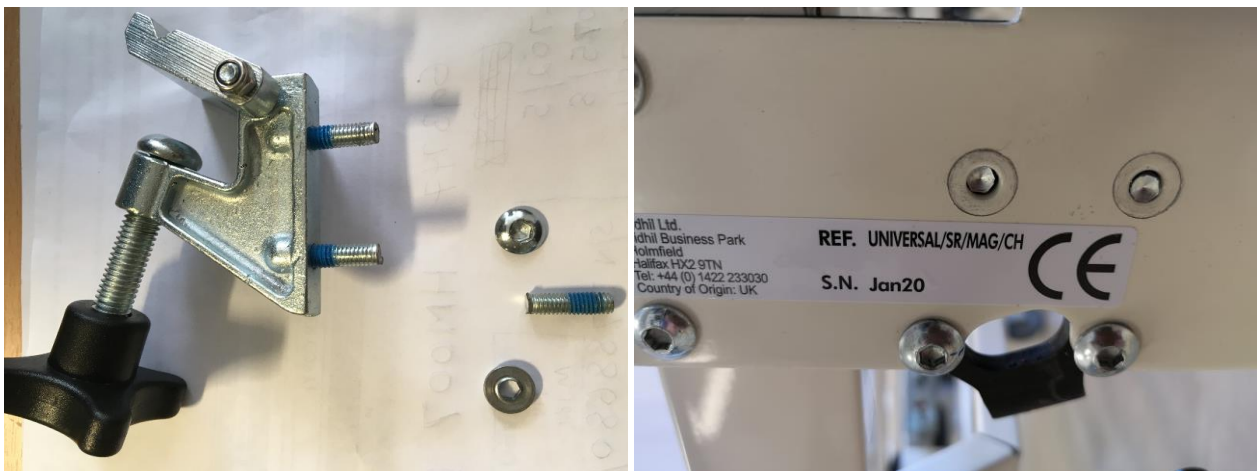
Drive DeVilbiss Healthcare Ltd has identified an issue relating to the service and maintenance of the affected bed rails. When the two bolts that hold the clamp bracket in place (as shown below) are over-tightened the head of the bolt can shear off.

Bed rails with the bolts that are intact remain safe to use and will continue to meet the physical test requirements of BS EN 60601-2-52.

If checking a rail prior to its next scheduled service interval, check there is no movement between the plate and clamp bracket shown in this document; whilst no movement is present there would not be a requirement to further tighten the fixings.

Providers should ensure that the fixing bolts are changed at the next service of the bed rail. Providers should contact Drive DeVilbiss Healthcare Ltd to arrange for replacement bolts to be delivered. Replacement bolts will be supplied free of charge. Providers are not to source their own bolts unless permission is granted by Drive DeVilbiss Healthcare Ltd.
